An Evaluation and Analysis of Past Landfill Closures in Puerto Rico as Guidance for Current and Future Closures

STREAMS Task Order 99

Innovative Waste Consulting Services, LLC
Gainesville, Florida

September 2011

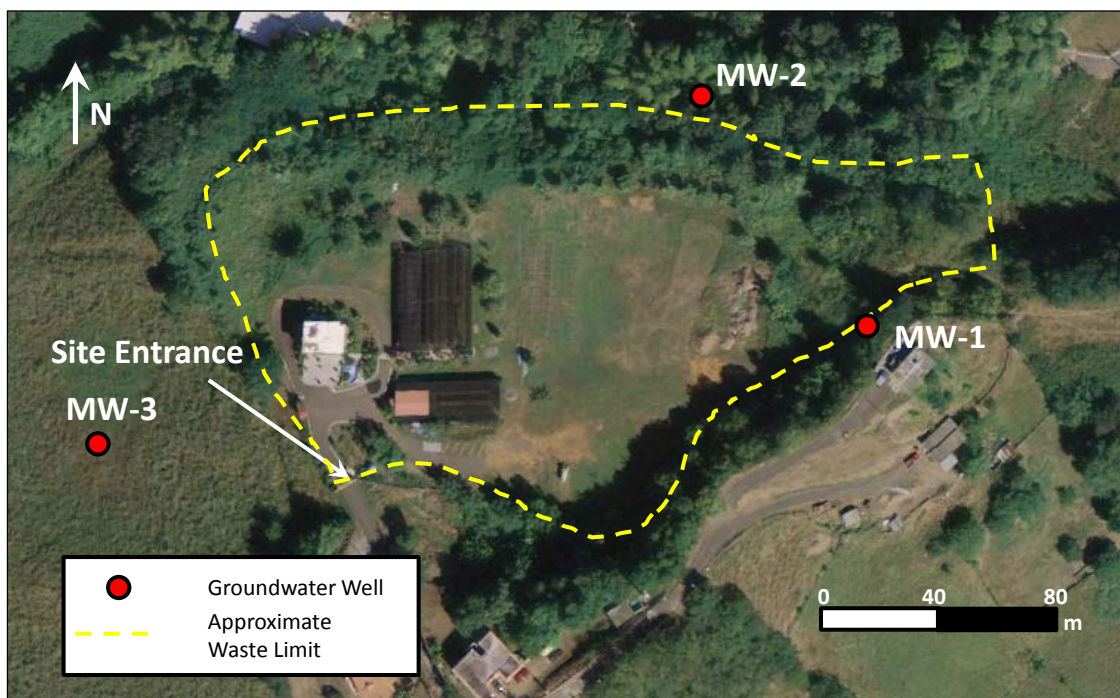
In the March 2002 letter, the JCA also described the findings from a February 2002 site inspection. During the inspection, the JCA located three groundwater monitoring wells on site (MW-1, MW-2, and MW-3), evaluated the condition of the wells, measured the depth of each well, measured the depth to water in each well, and determined the material and diameter of the pipes. MW-1 and MW-2 were found to be dry. Table 0-2 provides the well data collected by JCA during the site inspection. Figure 3-2 shows the approximate proposed location of the wells according to the closure plan for the site—no as-built locational data was available for the wells.

ID	Gradient	Condition of the Steel Cover	Well Depth (ft)	Water Level (ft)	Product Level	Height and Diameter of Case	Well Diameter
MW-1	Up gradient; Southeast	Acceptable; No Lock	93.18	Dry	None	58' 4"	2.0"

ID	Gradient	Condition of the Steel Cover	Well Depth (ft)	Water Level (ft)	Product Level	Height and Diameter of Case	Well Diameter
MW-2	Down gradient; North	Acceptable; No Lock	12.73	Dry	None	3.5' 3.5"	2.0"
MW-3	Down gradient, West	Acceptable; No Lock	28.87	27.68	None	2.54' 5.5"	4.0"

Figure 0-2. Aerial Photograph of Rincón 1, Inferred Waste Boundary, and Approximate Location of Groundwater Monitoring Wells

JCA recommended that the municipality run integrity tests on the wells to evaluate the presence of obstructions or breaks in the wells. They further recommended that the wells be evaluated for future use in monitoring activities at the site. The March 2002 letter is the last piece of correspondence that was available to the project team.

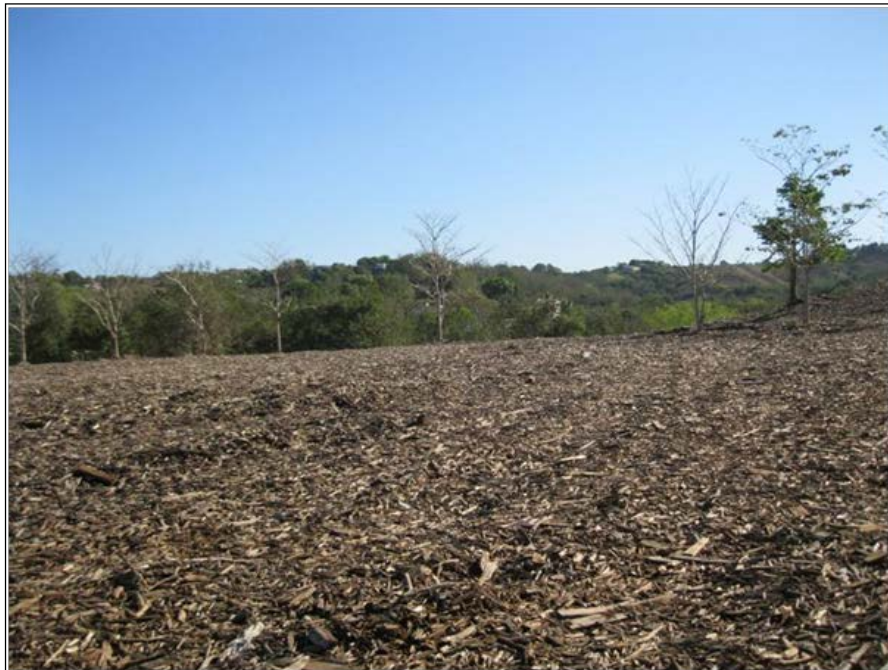
Although the entire perimeter was not accessible or visible at the time of the visit, fencing was in place along the southern edge of the property near the site entrance. The main entrance to the site, located to southwest of the site, had a gate and signage. A majority of the site (approximately two-thirds) was covered with a layer of mulch of indeterminate thickness (Figure 3-3). It was unclear whether a topsoil or clay layer was present beneath the mulch cover. Additional photos of the site are included in the photographic log in Appendix B.

Figure 0-3. Landscape View of Rincón 1 Looking to the North.

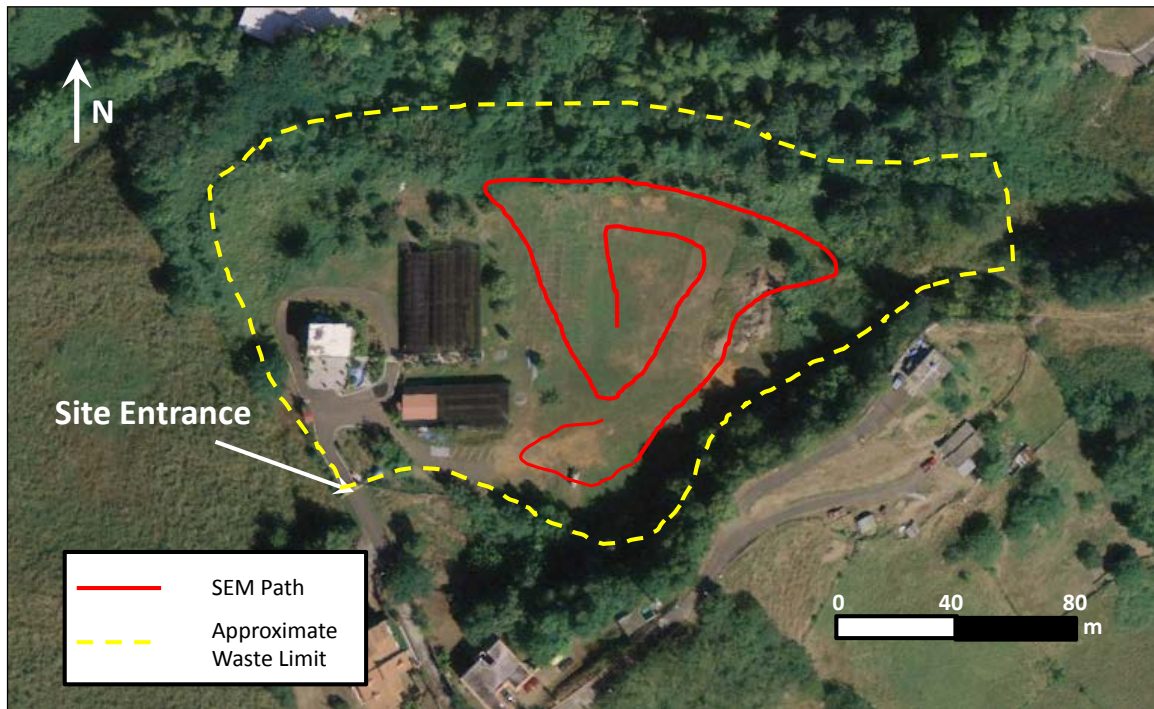
Figure 3-5 shows the approximate waste limit based on historical information and the approximate methane surface emissions monitoring (SEM) path followed at the site. No methane surface concentrations exceeded 500 ppm during the monitoring period.

Furthermore, no concentrations of methane above background were detected. As mentioned previously, the field measurement was limited to only methane surface emissions so that the other targeted facilities could be visited within the project team's field schedule. The SEM path that was taken as shown in Figure 3-5 covers the portion of the site that had a mulch layer in place. The project team did not have historical information about the site's actual disposal footprint prior to the field study, so the SEM evaluation was limited to the area which the team suspected had historical waste disposal.

Figure 0-5. Surface Emissions Monitoring Path at Rincón 1

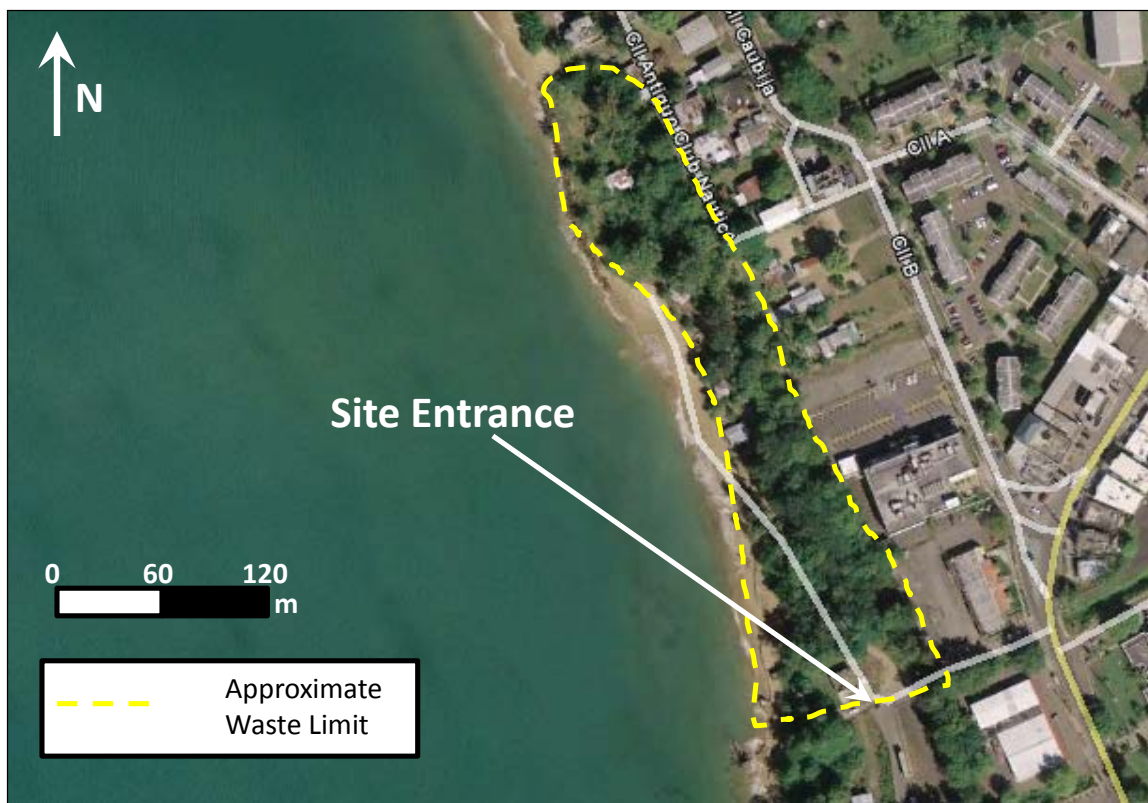
Figure 0-6. Aerial Photograph of Rincón 2 and Approximate Waste Boundary

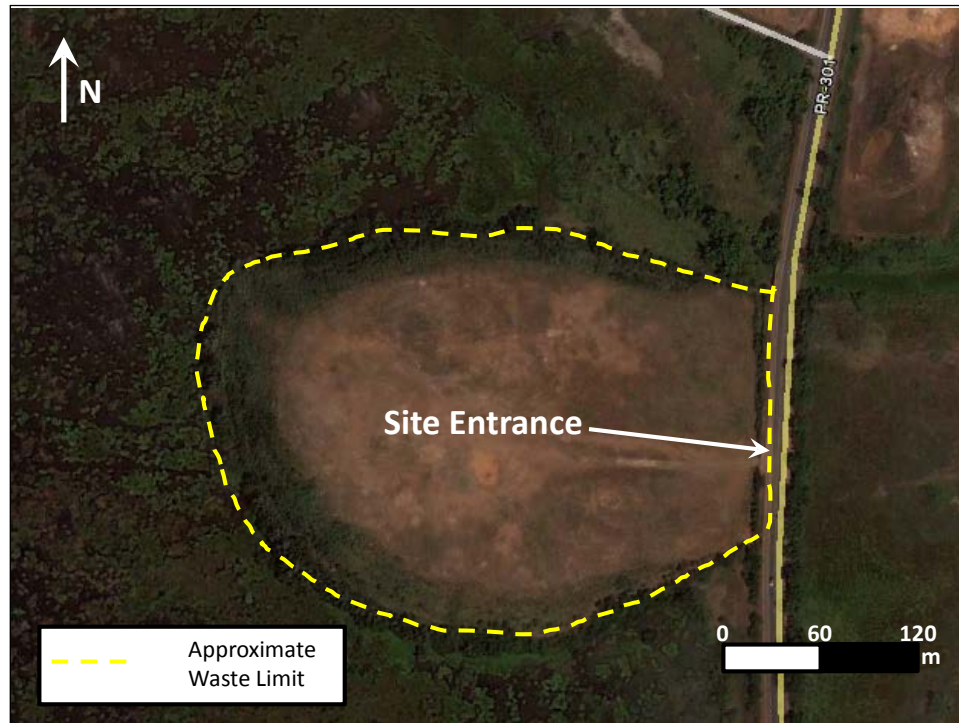
Figure 0-11. Aerial Photograph of the Closed Cabo Rojo Municipal Landfill and Approximate Waste Boundary

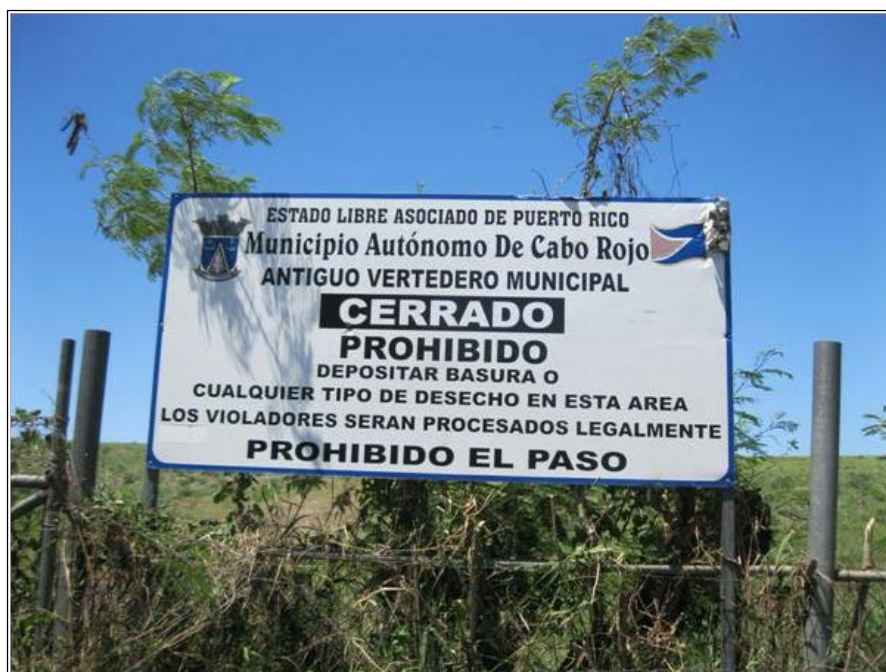
From the main entrance to the landfill off of PR-301, the site was fenced with chain-link fence, and signage indicating the site as a closed landfill was visible from the road (Figure 3-12). Barbed wire fencing was present on the south side of the landfill; the presence of fence along the northern and western sides could not be assessed because of dense vegetation and steep slopes that limited access to the bottom of the slope. The landfill had a relatively gentle slope upward towards the west from PR-301. An unpaved access road was present that ran toward the west from the facility's entrance. The entrance had a gate and a lock.

Figure 0-12. Closure Signage Posted at the Closed Cabo Rojo Municipal Landfill

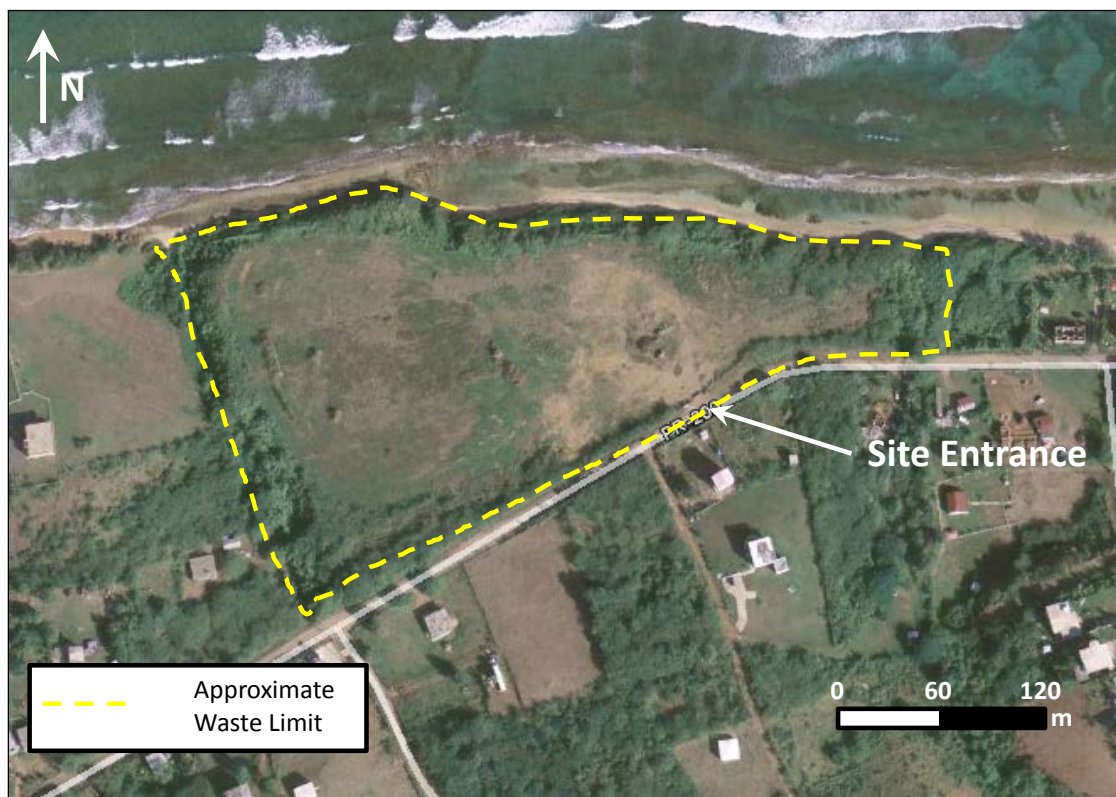
Figure 0-15. Aerial Photograph of the Closed Vieques Landfill and Approximate Waste Boundary

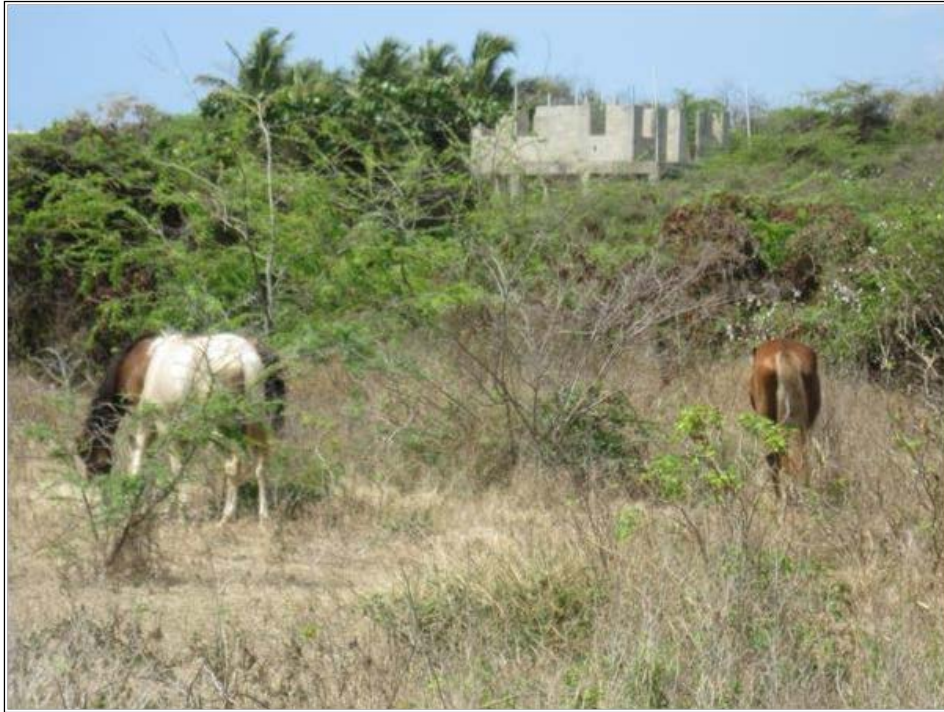
The landfill was mostly flat and predominantly level. The northern slope could not be accessed so it is unknown whether this portion of the landfill had a gradual or steep slope. A small herd of horses was grazing within the landfill's limits along with several trails (Figure 3-17), small pits that appeared to be dug by an animals (or humans to collect water for animals) as well as manure were found throughout the site. No leachate seeps were visible at the site.

Figure 0-17. Herd of Horses Grazing at the Closed Vieques Landfill

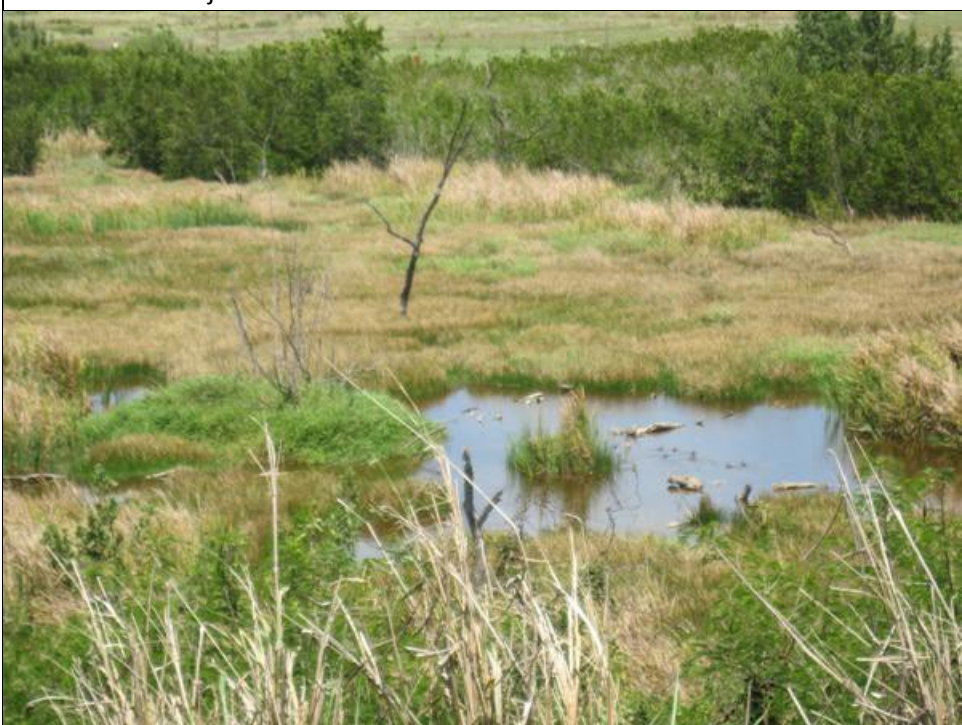
<p>View of a low-lying wetland area that appeared to be outside of the landfill footprint to the northwest.</p>

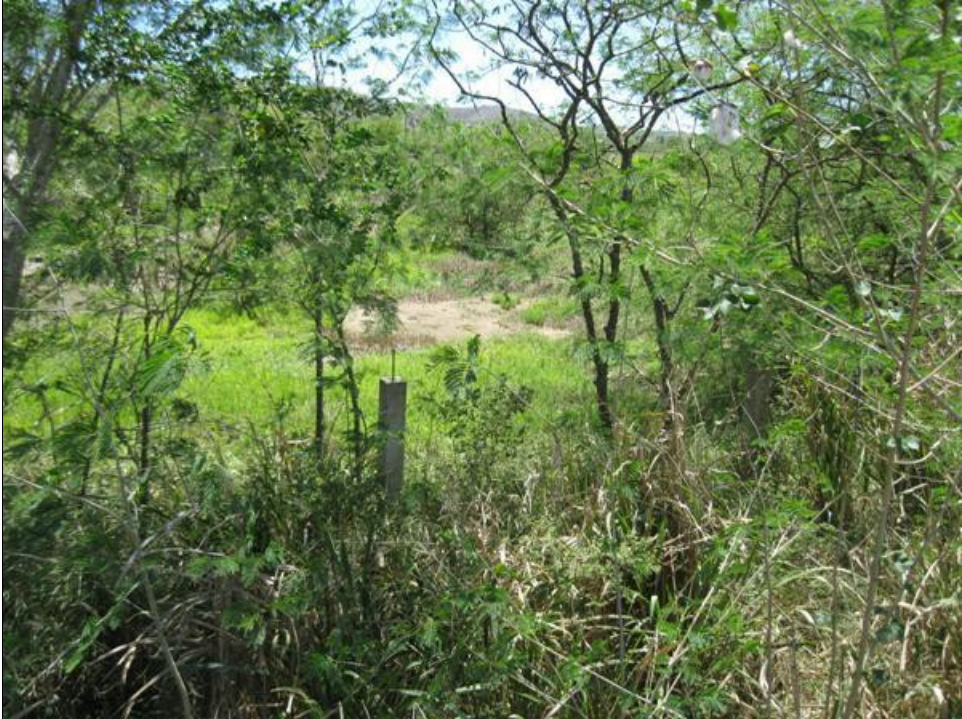
<p>Photo #: Cabo Rojo Landfill 9</p>

<p>Description</p> <p>View of an apparent property boundary marker towards the south side of the landfill.</p>
<p>Photo #: Cabo Rojo Landfill 10</p>

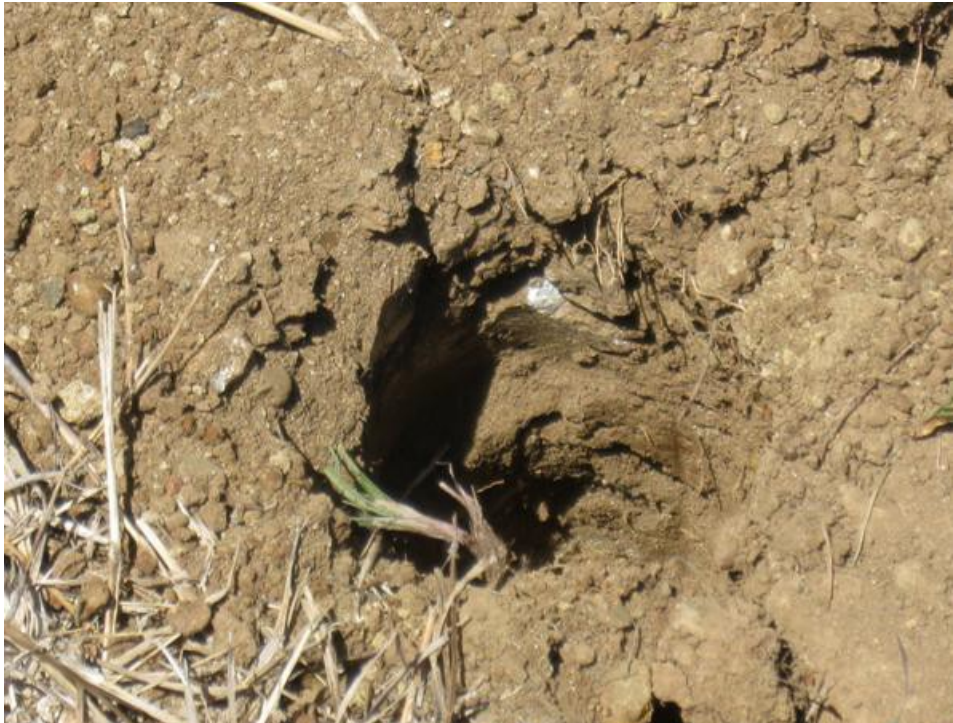
<p>Description</p> <p>View of borehole prior to hydraulic conductivity testing.</p>

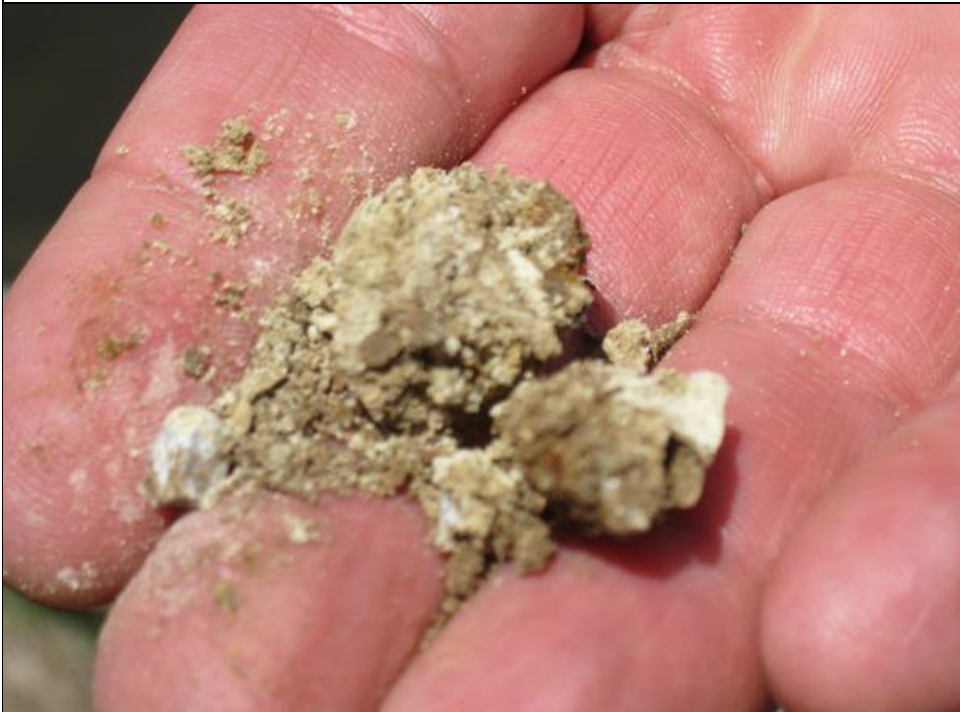
Photo #: Cabo Rojo Landfill 11	Description

<p data-bbox="1156 241 1440 493">Close-up view of clayey cover excavated as part of borehole advancement for hydraulic conductivity testing.</p>

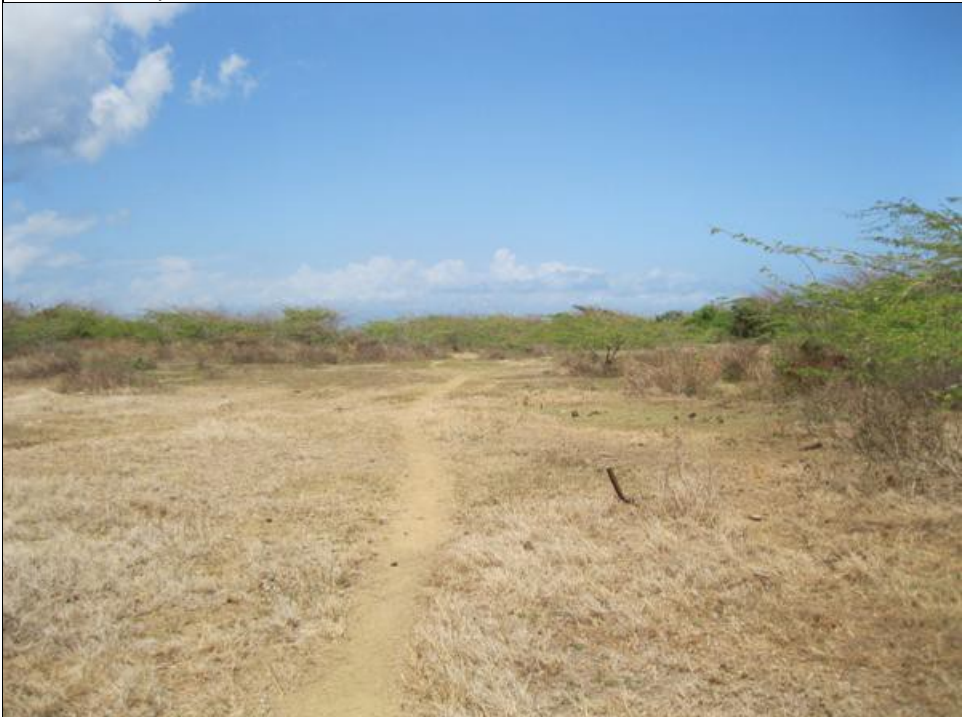
<p>Top deck of the landfill.</p>

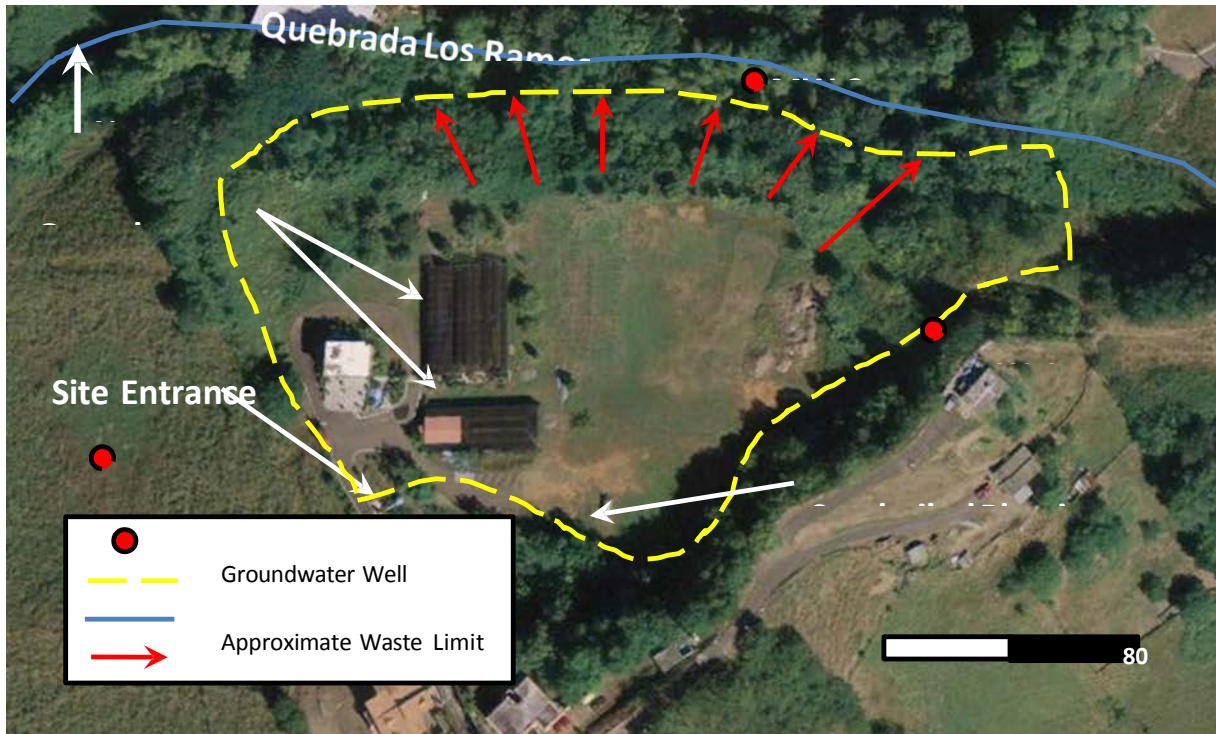
Figure F-1. Aerial Photograph of the Rincón Municipal Landfill with Supplemental Site Information.

1. Groundwater well locations are approximate based on information gathered from a site inspection conducted by EQB in February 2002.
2. The downward surface grade arrows shown in the figure are conceptual and represent only relatively steep slopes as identified in the field by the project team.

3. The waste limit shown is approximate based on information provided in the closure plan prepared for the site by Garcia, Cabot y Asociados in 1994.
4. The location of the stream, "Quebrada Los Ramos," is approximate and was adapted from a similar depiction within Google Maps.

5. The location of the stockpiled plastics is approximate and is based on the visual observations of the project team during the site visit.
6. The closed landfill has been used as a plant nursery for an unknown period of time. Historical documents indicate that the municipality sought permission for an alternative use of the landfill sometime before March 2002. Greenhouses and numerous potted plants were found at the site during the site visit.

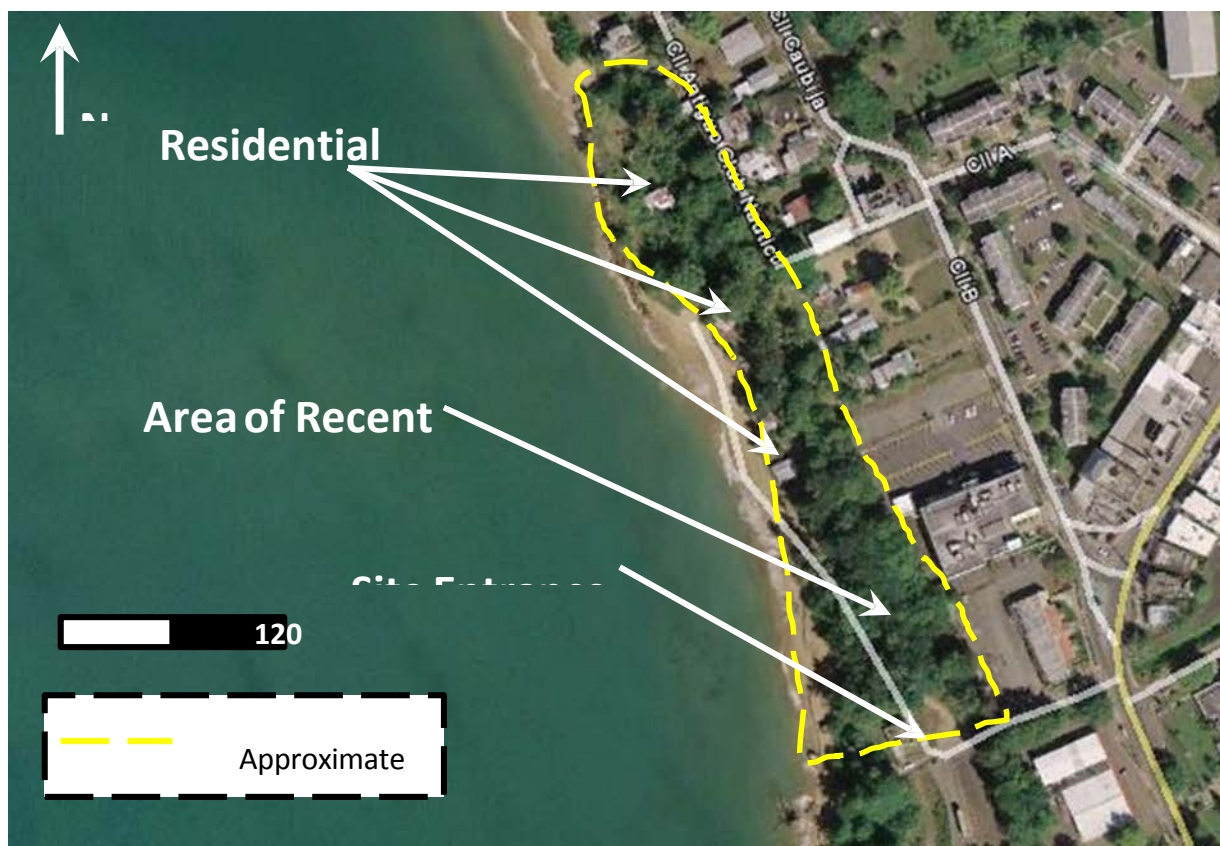
Figure F-2. Aerial Photograph of the Closed Rincón Landfill with Supplemental Site Information.

1. The waste limit shown is approximate based on information gathered in the field.
2. The “Area of Recent Waste Deposits” shown in the figure points to the general location where apparently fresh garbage had been deposited. Numerous discrete piles were observed throughout the site; however, the piles were predominantly concentrated at the south end of the site near the entrance.
3. Inhabitants of the buildings identified in the figure confirmed that the structures constructed on the landfill surface were, in fact, residential buildings.

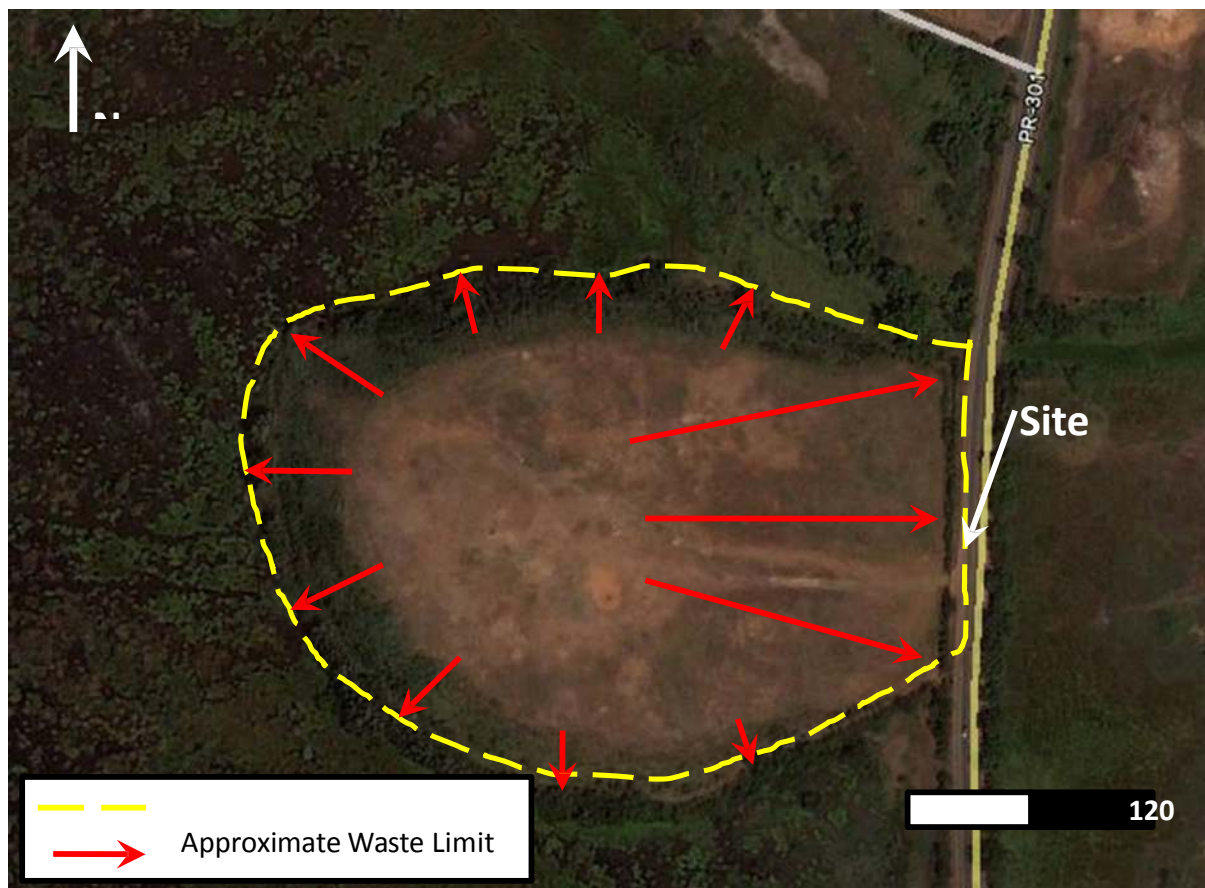
Figure F-3. Aerial Photograph of the Cabo Rojo Municipal Landfill with Supplemental Site Information.

1. The downward surface grade arrows shown in the figure are conceptual and represent only relatively steep slopes as identified in the field by the project team.
2. The waste limit shown is approximate based on information provided in the closure plan prepared for the site by Jordan, Jones, and Goulding in 1994, and information gathered in the field.

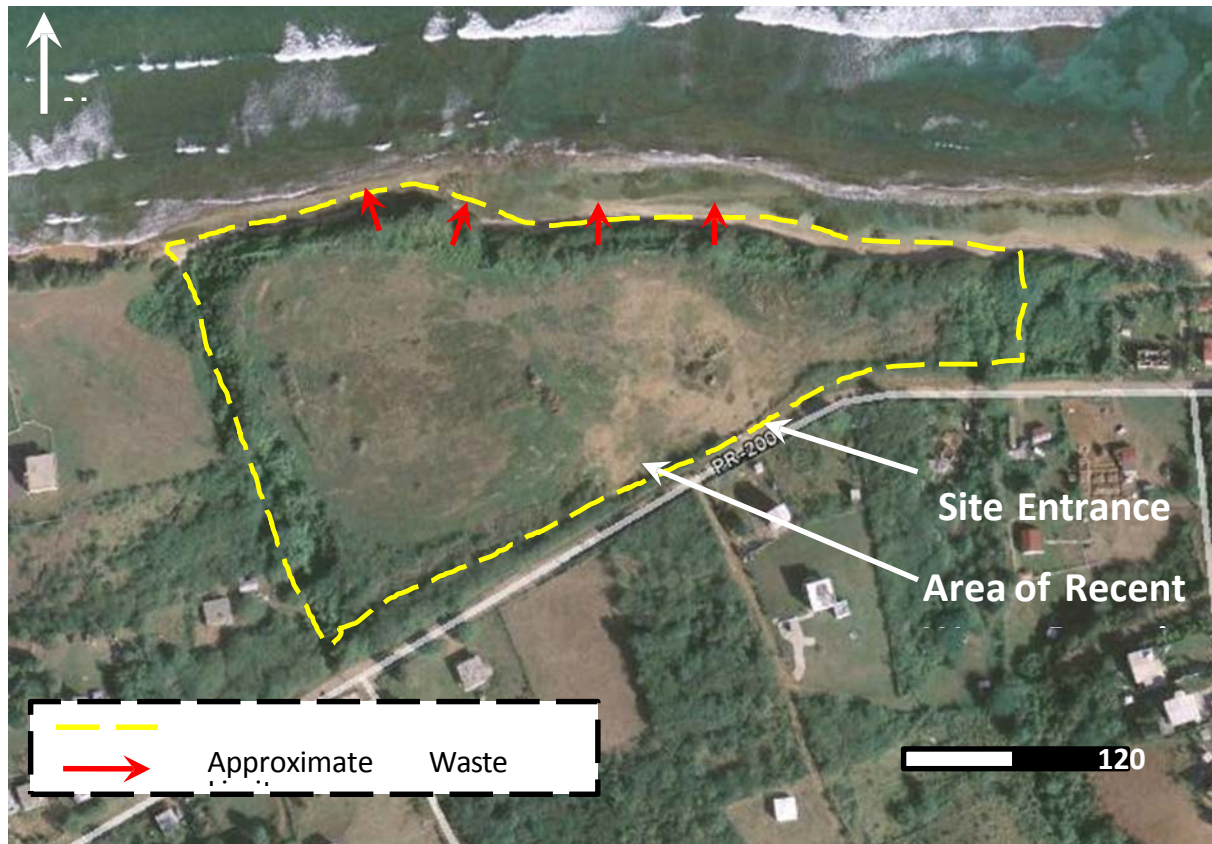
Figure F-4. Aerial Photograph of the Closed Vieques Landfill with Supplemental Site Information.

1. The downward surface grade arrows shown in the figure are conceptual and represent only relatively steep slopes as identified in the field by the project team. The site was predominantly flat with the only significant elevation change observed at the north end adjacent to the beach.
2. The waste limit shown is approximate based on information gathered in the field.
3. The "Area of Recent Waste Deposits" shown in the figure points to the general location where apparently fresh garbage had been deposited. Discrete piles were observed throughout the site.
